CORELESS FURNACE FLUXING BENEFITS FOR FERROUS FOUNDRIES

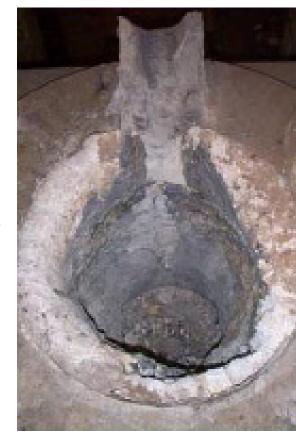
This family-owned foundry had noticed unexpected "lining arowth" in the 500 lb coreless induction furnace, at the rate of 25 mm (1-inch) per day. As shown above, a 2-inch thick layer of build-up occurred in 2 days of operation. There were attempts made to mechanically remove the build-up with a chipping hammer but the concern of damaging the lining prevented this to be a viable option. This became an emergency situation due to the rapid reduction of the furnace capacity and resulting loss of production.

A piece of the build-up was analyzed and found to be a combination 2MnO·SiO2, tephroite, and 2FeO·SiO2, fayalite. Actual build-up chemistry was found to be: 69.4% SiO2, 11.2% FeO, 6.7% MnO, 6.6% Al2O3, 2.7% CaO, and 1.7% MgO. It should be noted that the FeO and MnO levels were higher than normal.

Superheating the molten metal bath at the end of the heat was attempted to remove the build-up but did not work. However, success was achieved when continuous Redux EF40 (Patent 7,618,473B1), fluoride-free flux additions to the charge (1 lb flux per ton of metal) were done. The foundry was able to reestablish the furnace capacity without any damage/wear to the domestic silica working lining.

It was later found that a recent change to a different "pig iron" coincided with the change in the sponge-like foamy black slag within the furnace. The slag change was attributed to the amount of FeO in the charge, i.e. from the condition of the pig iron. The foundry continued to use the pig iron but did modify the charge to keep the build-up manageable. This included the continuous use of flux.
